NRL/MR/6120--97-7957

Control of Lead in Drinking Water

13. ABSTRACT (Maximum 200 words) This report describes the installation of an NRL-developed epoxy lining in the drinking water distribution system in three buildings. Water was sampled before and after installation of the lining; the sampling data was interpreted after several confounding factors were identified and allowed for. Improper installation of the lining in one of the buildings led to its premature failure, and this was documented and analyzed. The lining is shown to be effective in preventing leaching of lead into drinking water. This technology is recommended as a routine method for excluding lead from drinking water distribution systems in buildings, and guidance for use in establishing contracts to install the lining is provided.

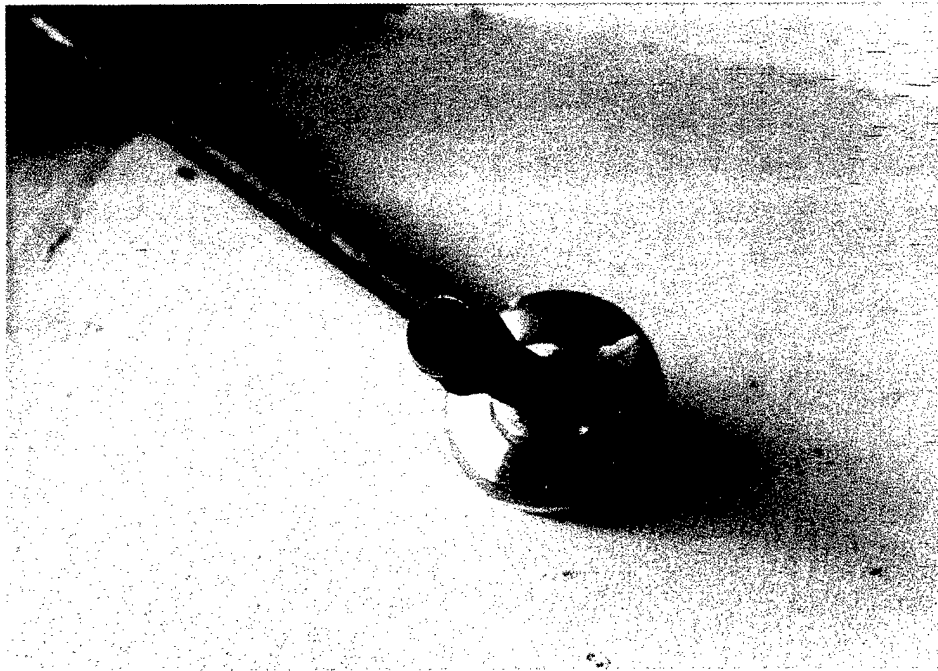
Some of the feed lines to bathroom taps were blocked with debris. Figure 3 shows the hot water line just behind the tap in room 214; this debris was packed hard and more than 3/4" deep.

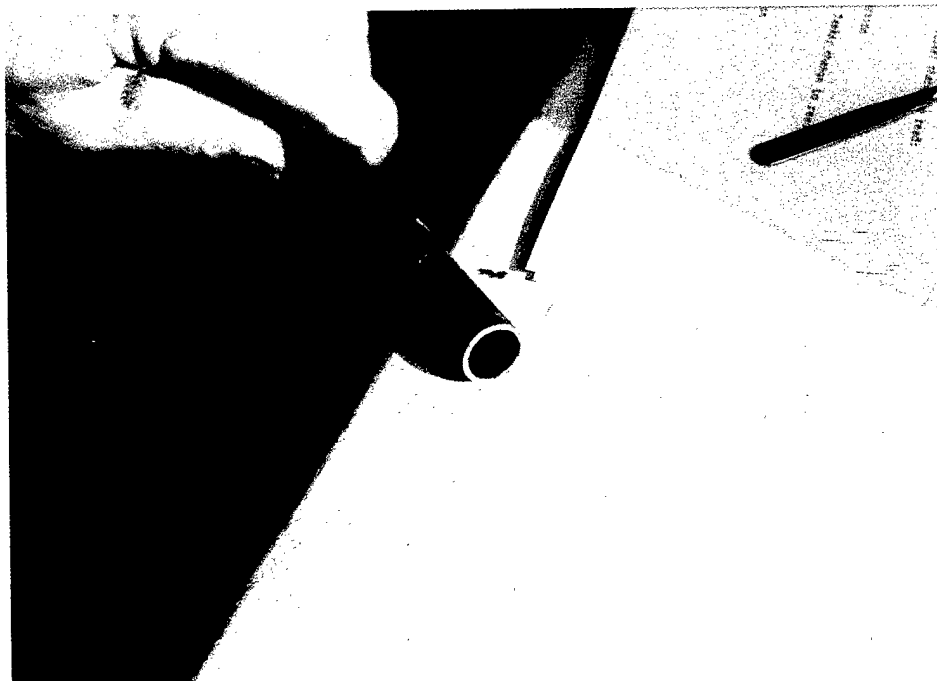
Figure
4

Paint in the cold water riser to room 214 was rippled, indicating that it sagged before drying; thickness is reasonable but the paint has entrained grit which makes it rough (Figure 4). Where this line became horizontal and entered the main, the coating was thicker on the bottom of the main (Figure 5).

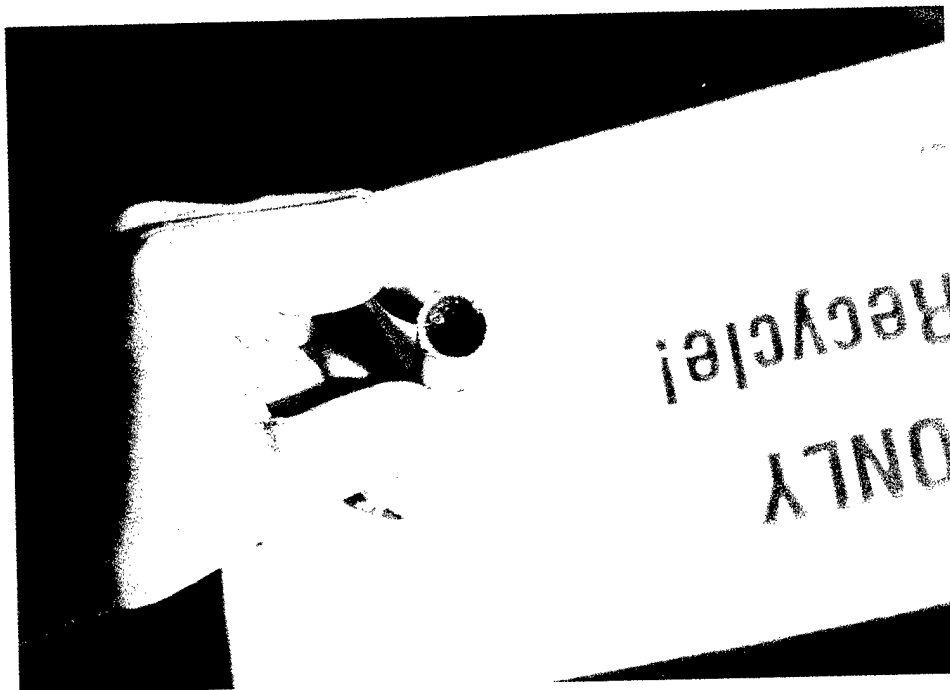
Figure
6

The cold water line to room 211 showed proper thickness and good adhesion, but contained much entrained grit (Figure 6). Some of the pipes, such as the cold water feed in room 210, contained excessively thick coating or no coating at all. In the cold water line to room 206, just behind the tap the coating is excessively thick and porous (Figure 7),

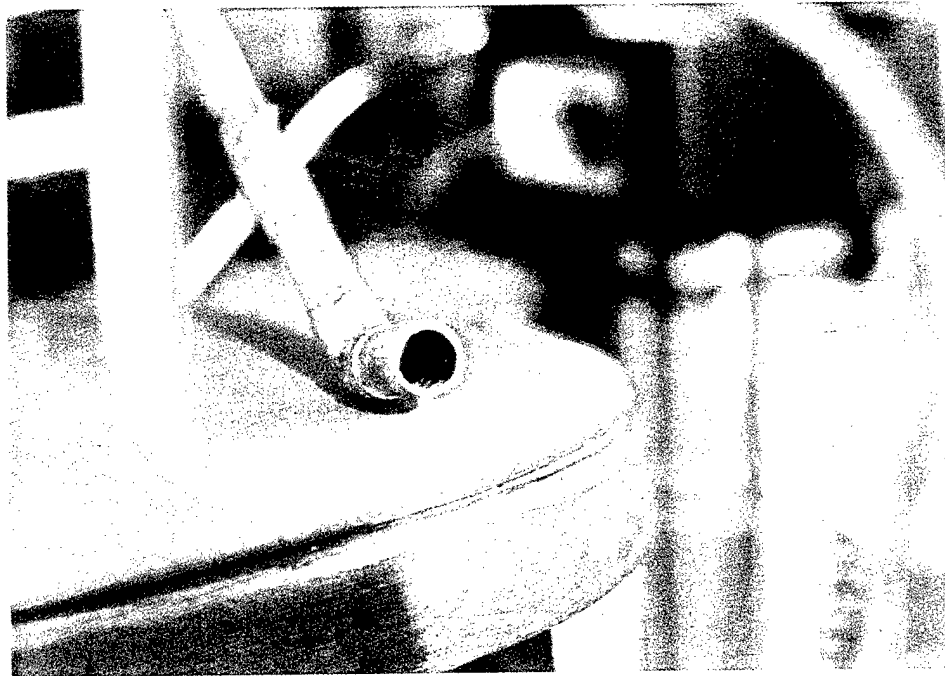
Figure
8

but 24 inches toward the main there is no coating at all (Figure 8). The cold water line (Figure 9) to the ladies room near the first-floor lobby and to room 207 was at the upper limit of thickness on the bottom and very rippled.

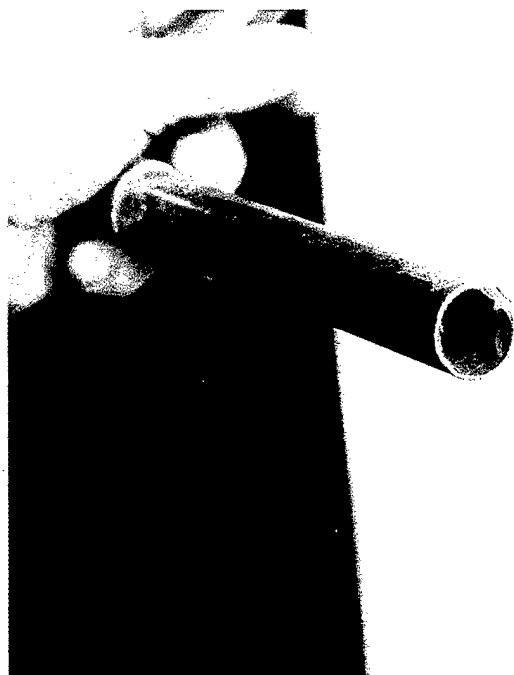
Figure
10

The hot water line leading to laundry on the first floor between room 107 and the booking office showed good adhesion, but the paint is excessively thick and severely rippled (Figure 10). The lining in the hot water pipe to room 106 (Figure 11) was at the maximum permissible thickness and showed ripples, good adhesion, and some evidence of grit in the paint.

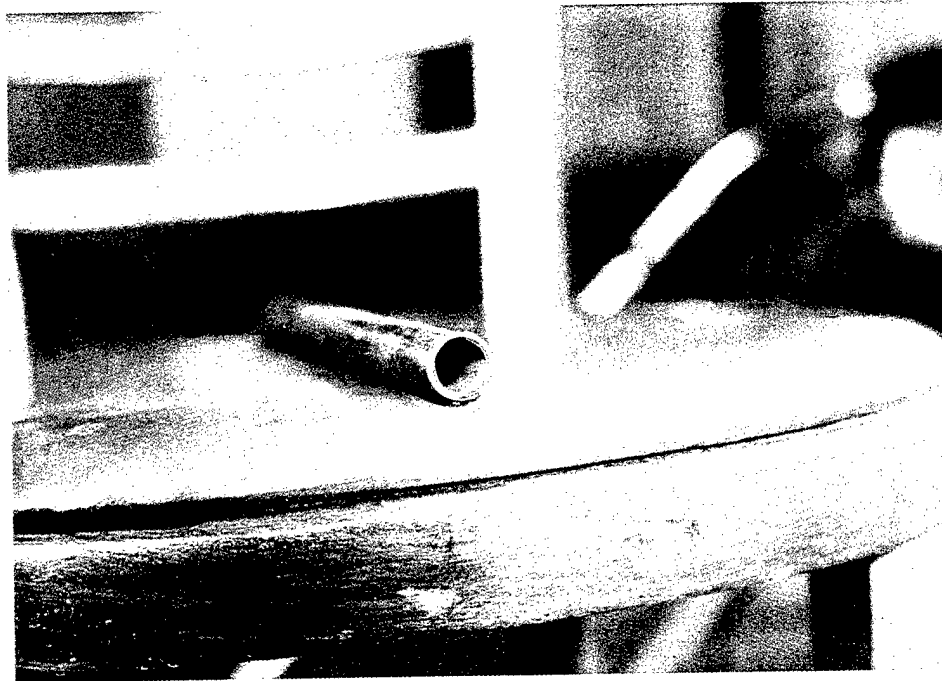
Figure
12

The lining in the cold water feed to room 105 (Figure 12) was excellent, showing proper thickness, good adhesion, and no contamination. Lining in the hot water line into room 101 was hard and smooth, adhered well, but was slightly thick on the bottom of the pipe nearest the tap (Figure 13).

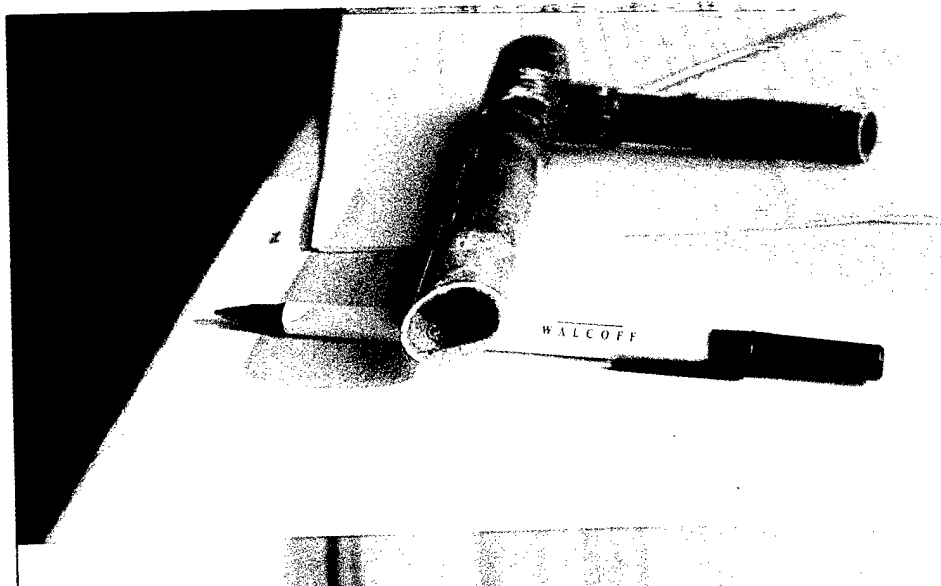
Figure
14

Workmanship in the cold water main is good at the north end but very poor at the south end. At the north end, the lining is generally smooth and glossy, with light rippling. Adhesion of the paint seems satisfactory. The paint is thicker on the bottom of the main at the north end of the building (Figure 14), but not so thick as to obstruct flow.

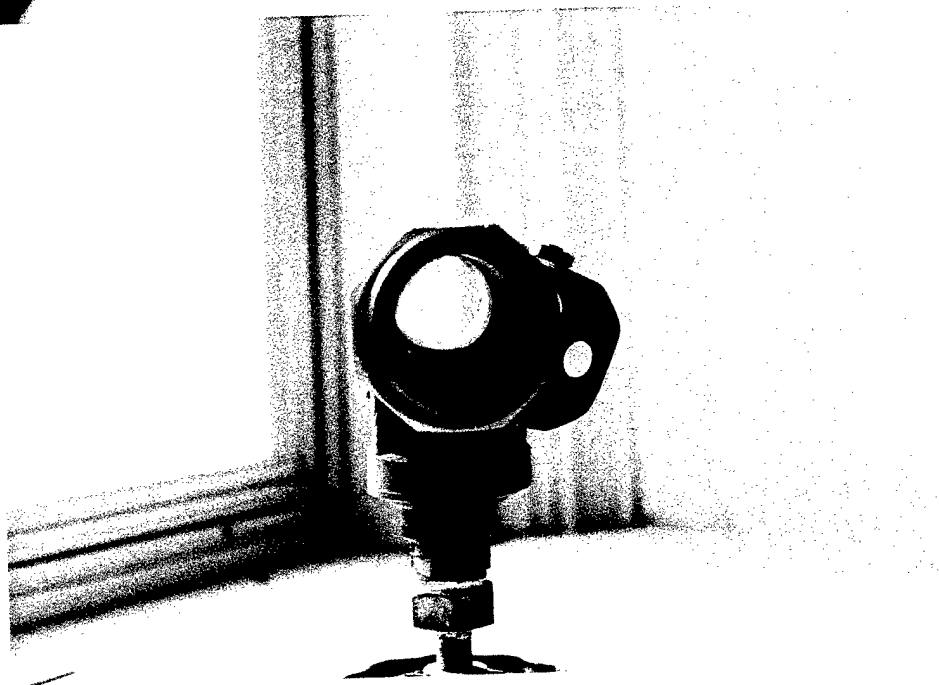
Figure 15 shows a valve and adjoining piping from the cold water main at the north end. The valve is operable but must pierce and crack paint in order to close. The coating is generally smooth, with light rippling but no blisters. Adhesion of paint seems satisfactory. Paint has a matte finish instead of the normal gloss.

All valves were painted, and most were inoperable (see Figures 15, 17 and 20 above). The contract explicitly required valves to be removed from the lines before painting.

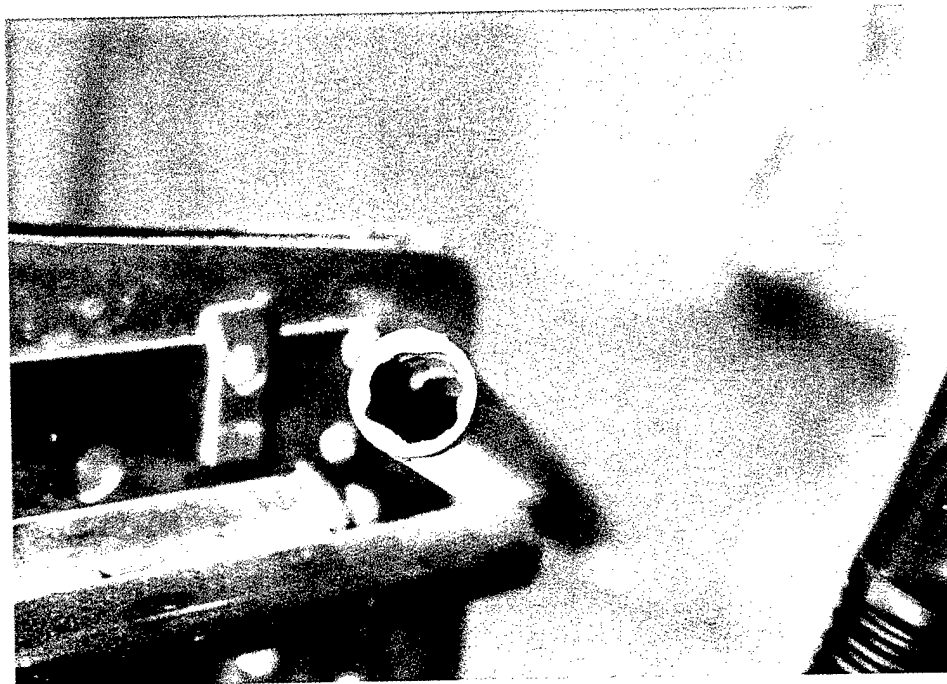
Figure
16

At the south end of the building, the paint is excessively thick and rippled (Figure 16). A valve in this line is painted open and cannot be operated (Figure 17).

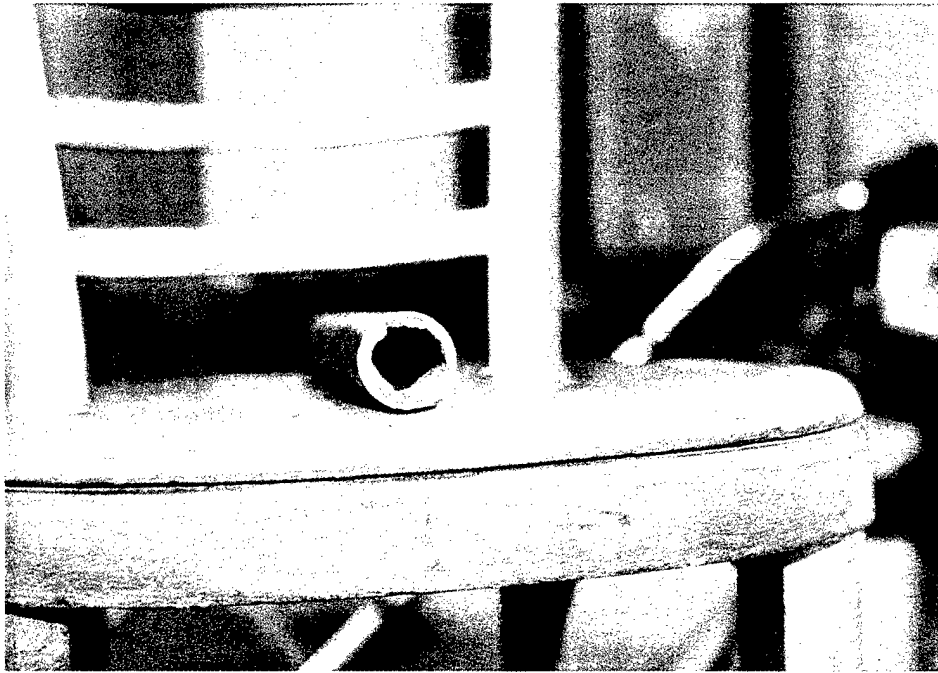
Figure
18

At the far south end of the building, the lining is excessively thick at one point, but stops abruptly leaving uncoated pipe. In a section of 1" cold water main from far south end of building, the paint is excessively thick at one end (Figure 18) but there is no paint at all at the other end (Figure 19). The roughness of the pipe surface at the uncoated end is very light on the bottom and sides, but there is no roughness at all on the top 60° of the pipe.

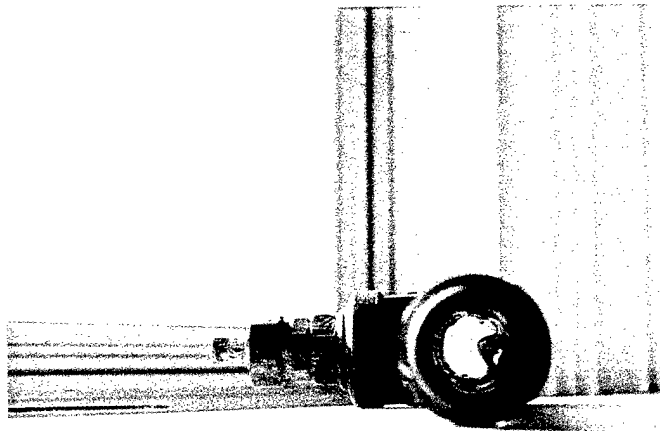
Figure 20 shows a section including a valve from the hot water main at the north end of the building. The thickness of paint in the pipe is acceptable, but the valve is painted open. A single blister about 8" long has formed at the top of the pipe. The interior metal surface of pipe is very smooth; there is no surface roughness at all.

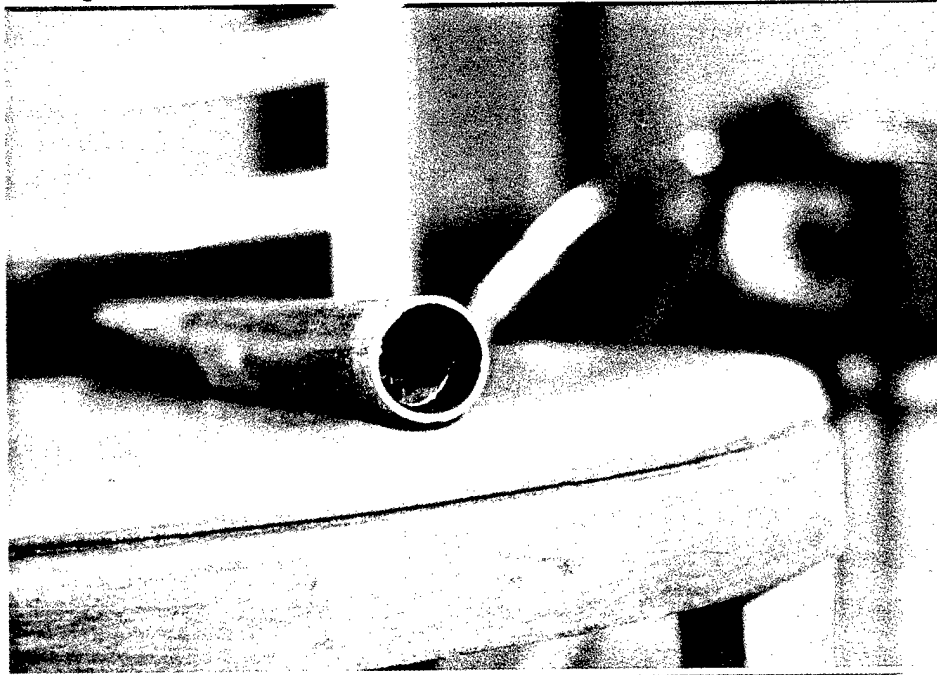
Figure 22 shows a section of pipe from the south end of the building. Adhesion to the bottom of the pipe is satisfactory, but paint on the sides and top of the pipe has lost adhesion to the metal and moved into the center of the pipe, where it may be broken loose by flowing water.

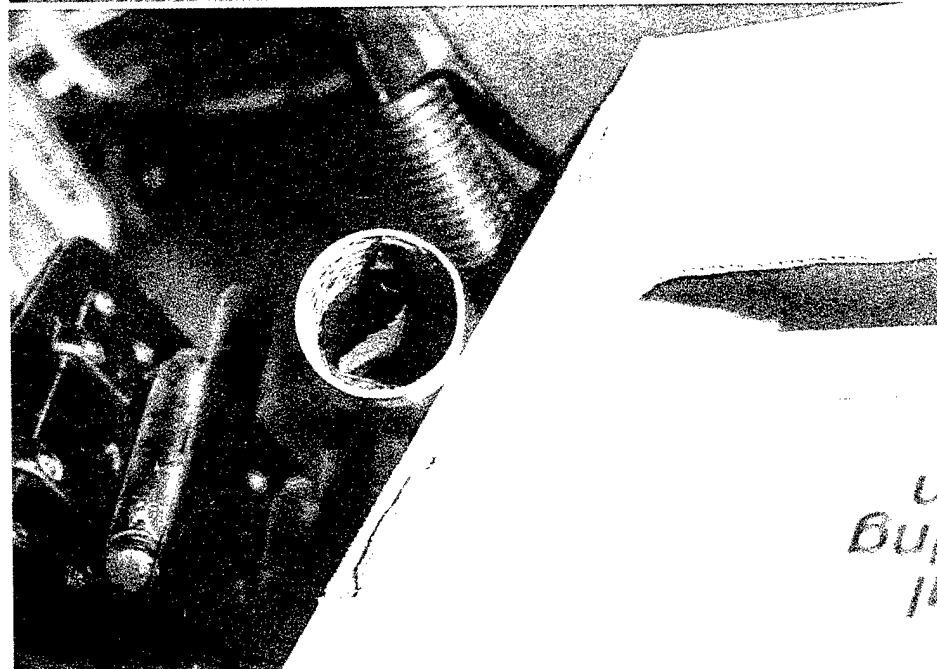
Figure 23 shows delamination of paint, leaving bare metal and flakes partially obstructing flow in hot water 2" pipe from ceiling in main hallway at south end of the building. The mottled black spots on the metal indicate that hot work has been done close to this site.

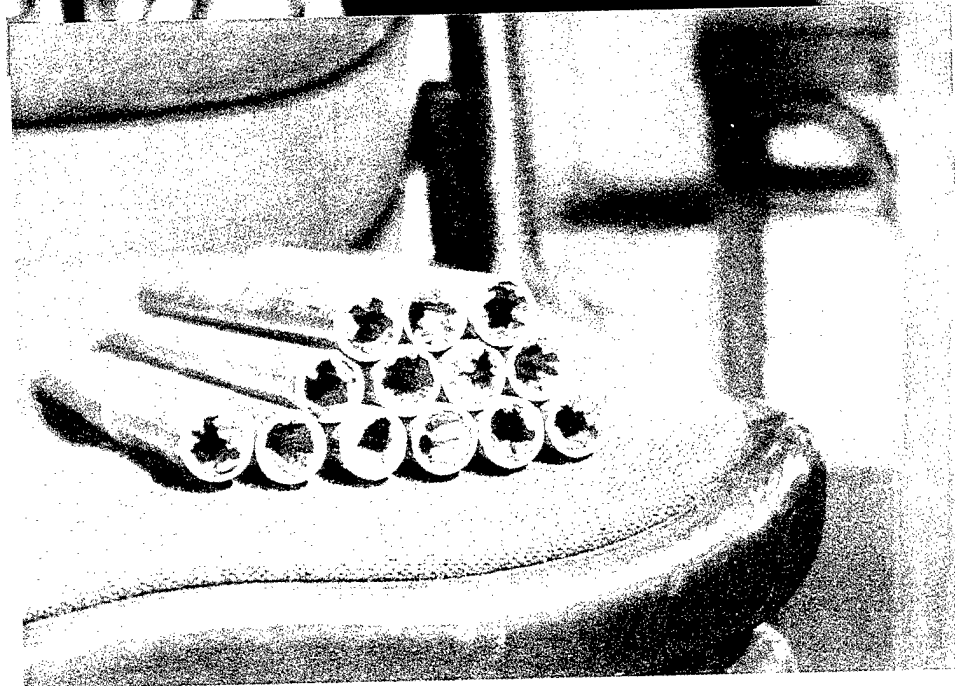
Figure
25

A 13-foot section of 3/4" hot water recirculating line from the far south end of the building was nearly obstructed by excessively thick paint. A pipe cutter was used to cut this pipe into 13 1-foot segments, and these are shown in Figure 25. The lining is not solid paint but is porous.

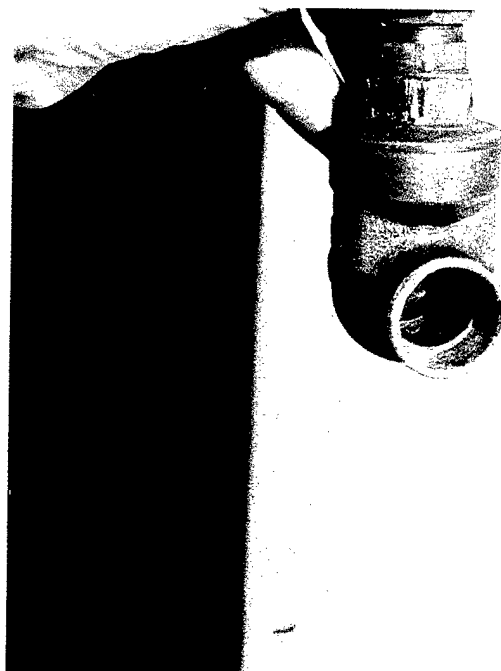
Figure 26 shows a valve from 3/4" hot water recirculating line which was not removed during painting. Paint covers the seat of the valve and prevents the valve from closing.

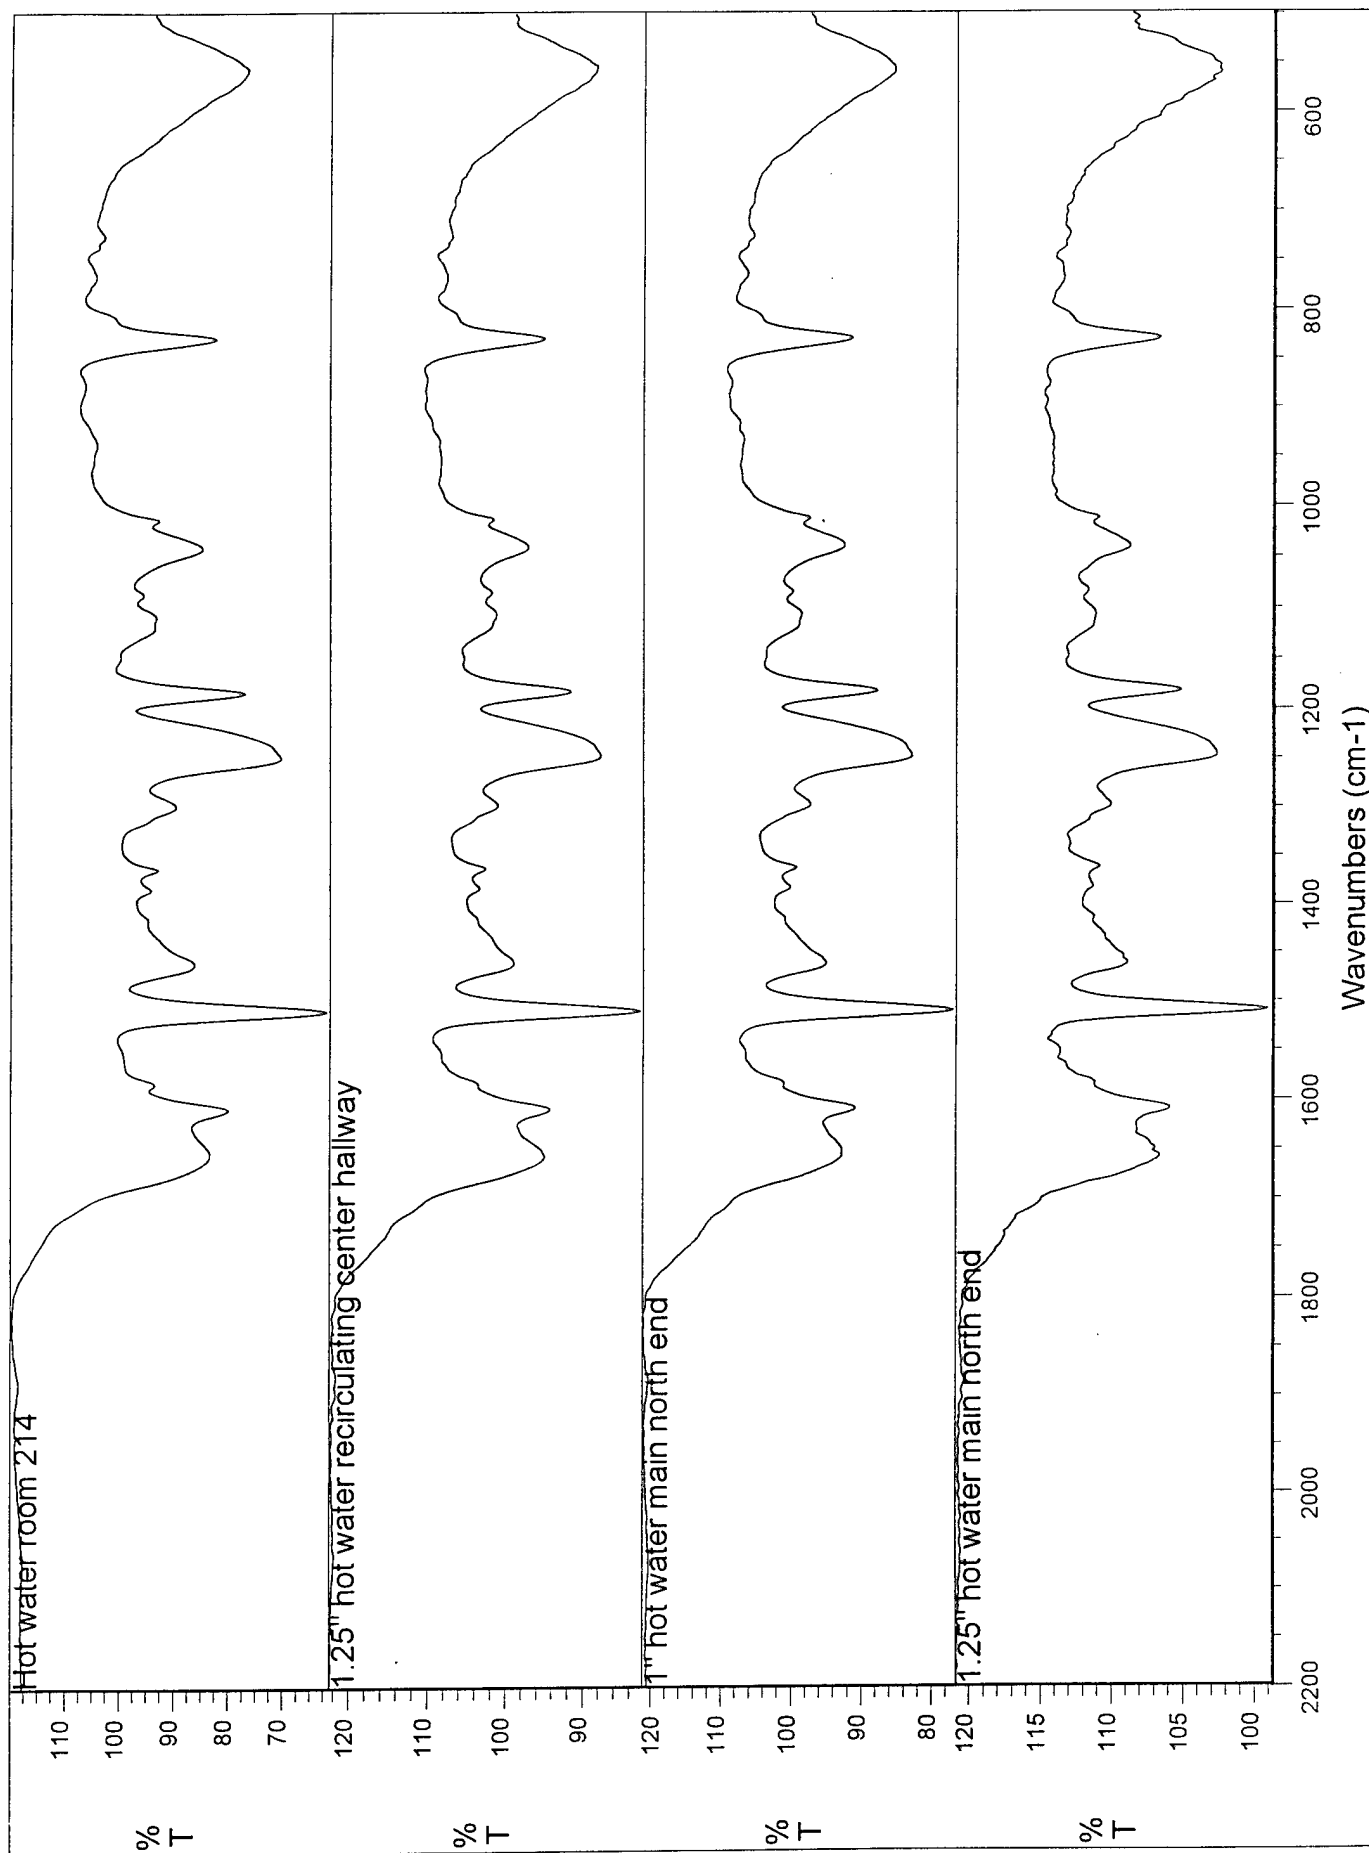
Manufacture and mixing of the lining. Infrared spectra of paint flakes were used to determine if the paint was manufactured properly and mixed properly. Figure 27 shows spectra of lining from four places in the building. The position and intensity of the peaks shows that the paint was properly manufactured and mixed.
